2D Outdoor Measurement

The Acoustic Camera as a Tool for Sound Source Localization

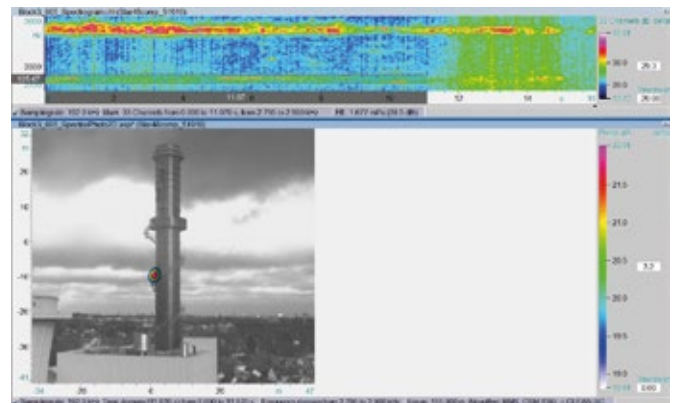
Fig. 1: Result of the overview measurement

During the first measurement with the Star Array in the far field, the surrounding staircase at the chimney can be clearly identified as the main noise source (Figure 1). The spectral analysis shows discrete frequencies indicating a whistling of the wind over the grating structure. Using the Acoustic Camera, it was possible to associate these frequencies with different sound sources at the grating structure of the staircase (Figure 2.1). In order to prevent this flow noise, the customer dammed the stairs with rubber mats.

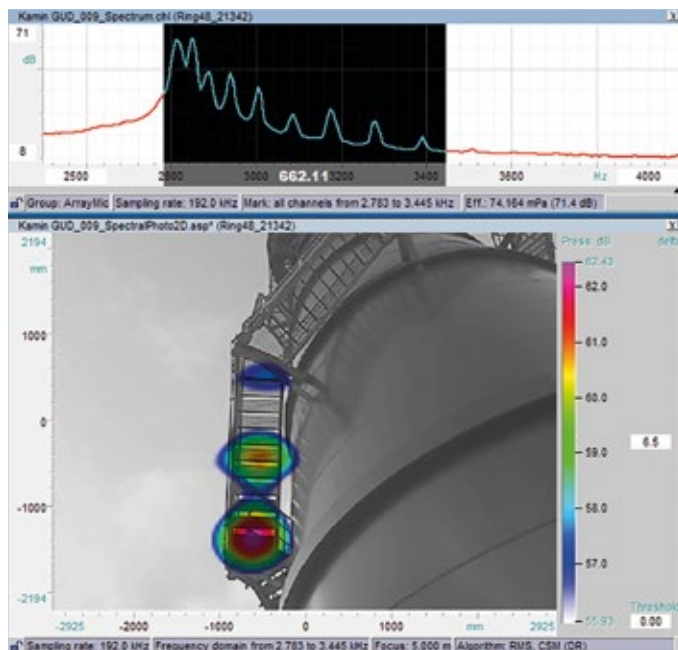
Fig. 2.1: Before acoustic optimization

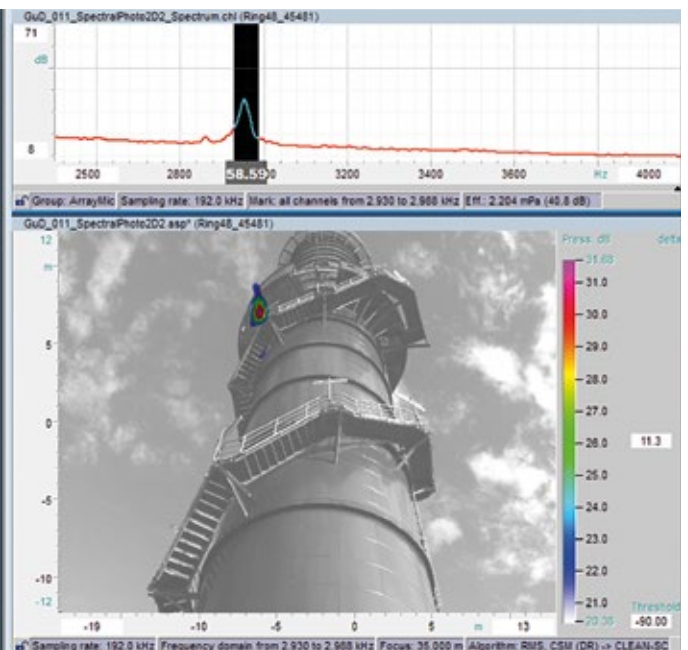
Fig. 2.2: After acoustic optimization

The follow-up measurement shows the success of this measure. Only one sound source in the upper part of the chimney can be found (Figure 2.2). This remaining sound source comes from the upper staircase, which the customer deemed irrelevant for the acoustic measurements so far. Subsequently, the flow acoustics of the upper stairs were also improved by installing additional rubber mats
