## The Acoustic Camera as a tool for machinery maintenance

This paper will explore the possibilities of using the Acoustic Camera to detect faulty machinery parts. Furthermore, potential savings when using the Acoustic Camera as a diagnostic tool will be examined.

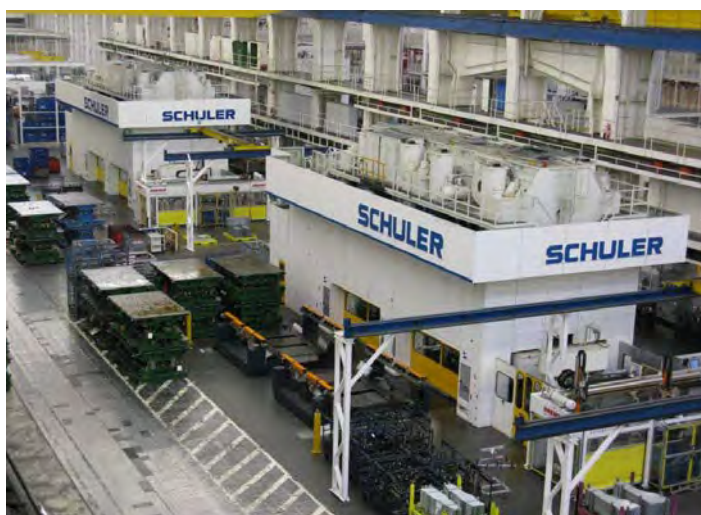
The best position for the measurement was on the upper part of the press. It is possible to open the machine to allow a view inside. Measuring around the press and from a distance is not constructive as the machine is encased by thick walls and the beamforming technology is not able to penetrate these walls (Figure 1).

The microphone array and the data recorder were lifted up on top of the press and the measurement was conducted during operation and without interrupting the production process.

Figure 1: left – overview of the plate press line; right – set-up of the Acoustic Camera on top of the plate press

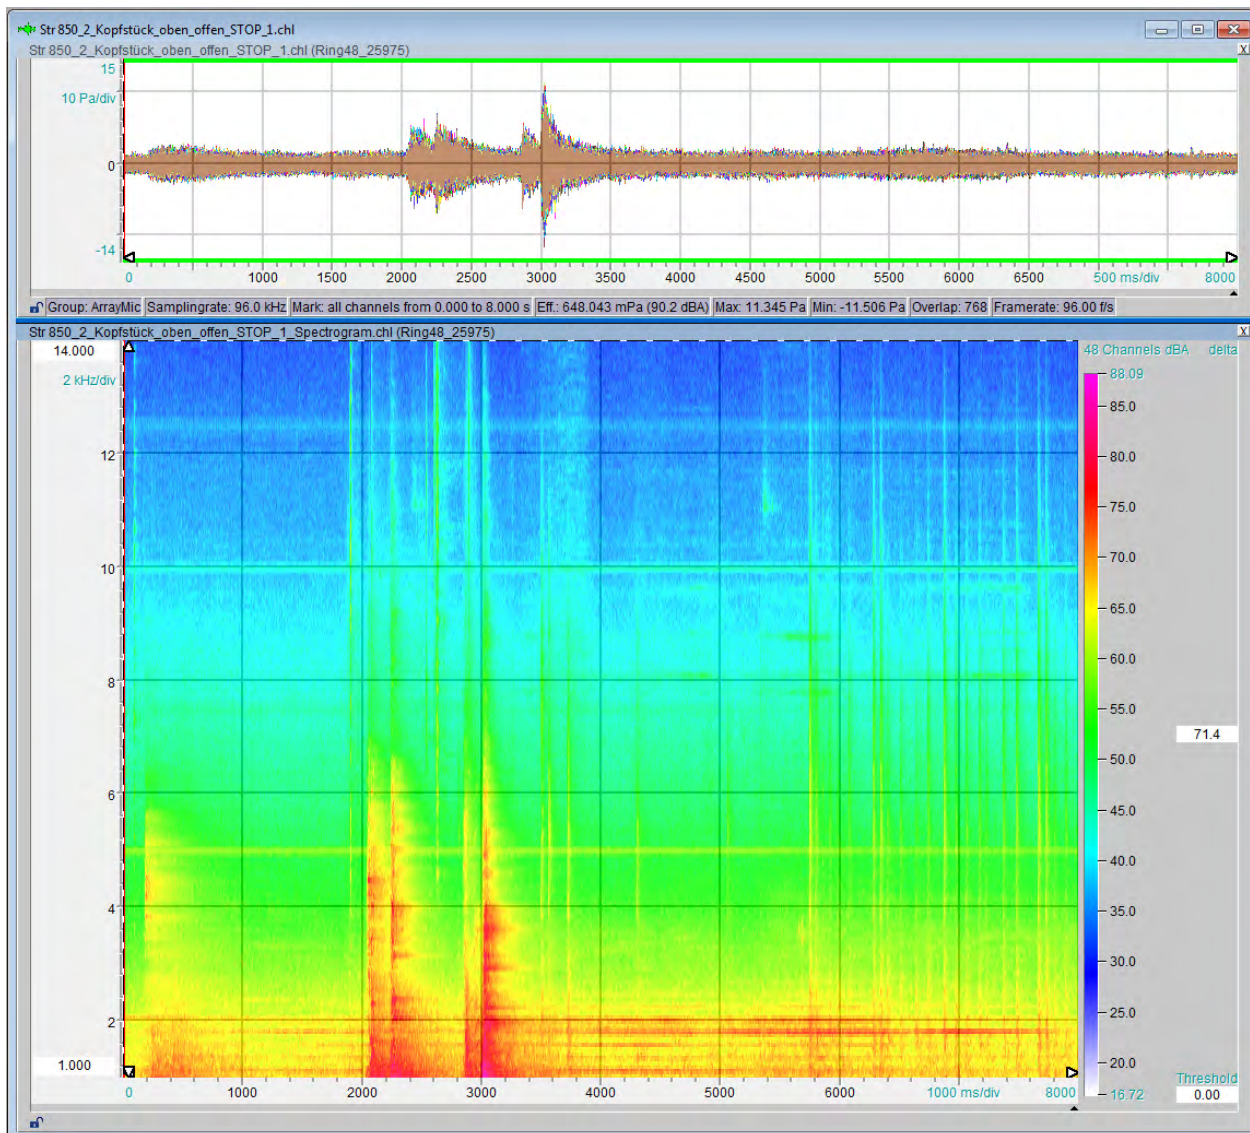
The first step in post-processing was the frequency-based analysis of the recorded data. Looking at the spectrogram, the process of pressing is distinctively visible in the channel-/time-data as well as the spectrogram (Figure 2 between 2.000 and 3.000ms)

Figure 2: channel-/time-data (top) and spectrogram (bottom) of an 8s recording

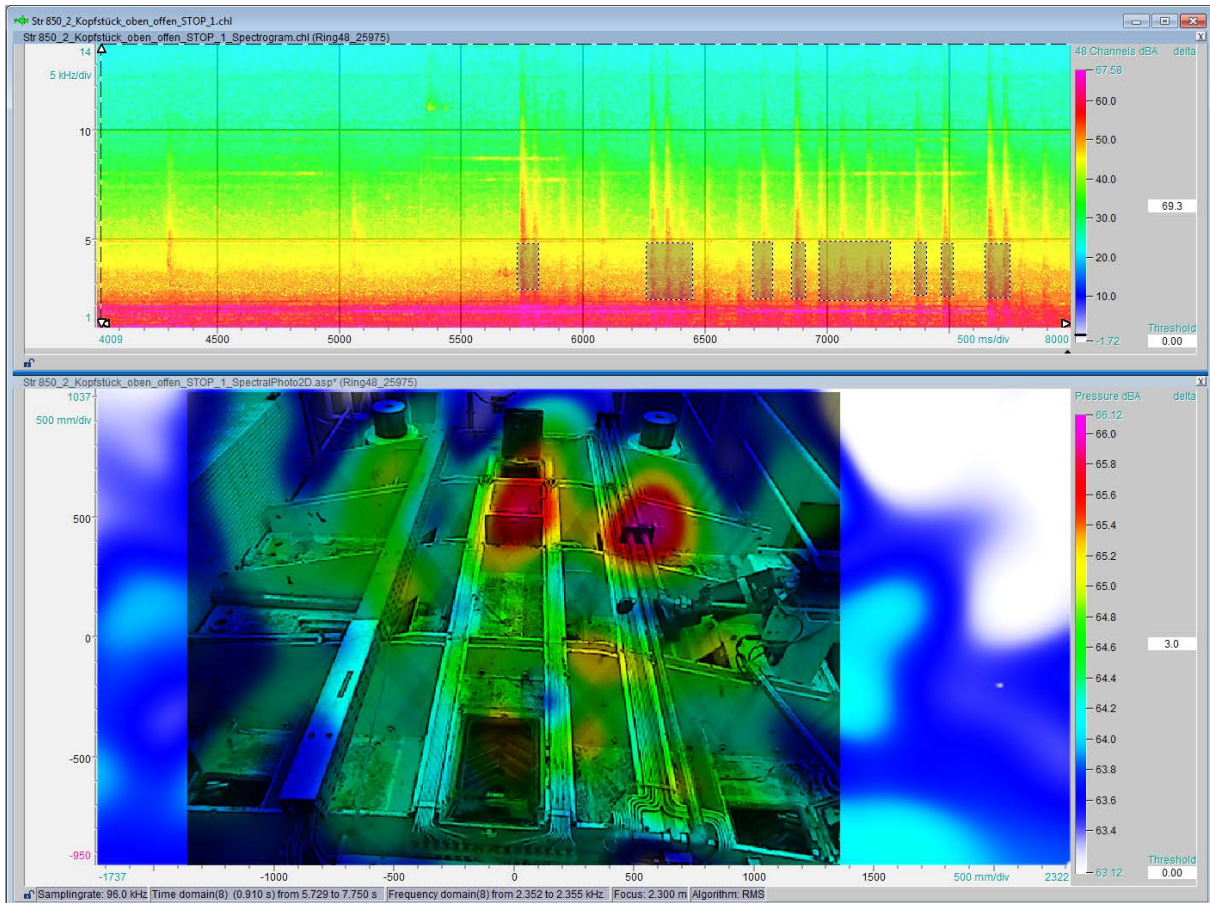
Several of those peaks in the range of 2,3 – 4,8kHz are marked and an Acoustic Photo is generated (Figure 4).

The photo clearly shows that the emitted frequencies are originating from a distinctive area. Upon closer investigation of the machinery itself it becomes clear that this press contains several gears and according to the area indicated it is easy to quickly identify the faulty gear.

Figure 4: spectrogram with marked peaks (top) and acoustic photo of sources for these peaks (bottom)

A new gear (Figure 5) was ordered to replace the old/ faulty one.

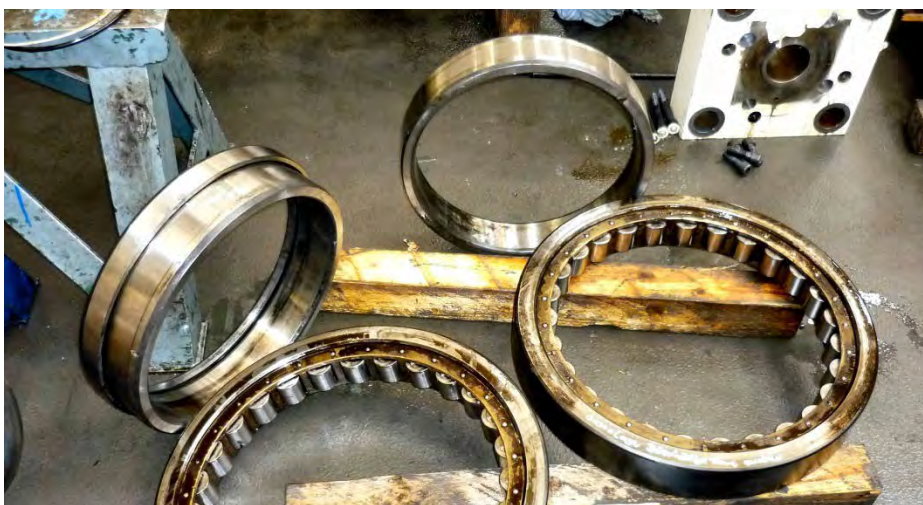
Figure 5: new and old gears
